DEPARTMENT OF TRANSPORTATION

Contract #: 04-0120F4Cty: SF/ALA Rte: 80 PM: 13.2/13.9File #: 1.28**WELDING INSPECTION REPORT****Resident Engineer:** Casey, William**Address:** 333 Burma Road**City:** Oakland, CA 94607**Report No:** WIR-027083**Date Inspected:** 20-Jan-2012**Project Name:** SAS Superstructure**OSM Arrival Time:** 700**Prime Contractor:** American Bridge/Fluor Enterprises, a JV**OSM Departure Time:** 1530**Contractor:** American Bridge/Fluor Enterprises, a JV**Location:** Jobsite**CWI Name:** As noted below**CWI Present:** Yes No**Inspected CWI report:** Yes No N/A**Rod Oven in Use:** Yes No N/A**Electrode to specification:** Yes No N/A**Weld Procedures Followed:** Yes No N/A**Qualified Welders:** Yes No N/A**Verified Joint Fit-up:** Yes No N/A**Approved Drawings:** Yes No N/A**Approved WPS:** Yes No N/A**Delayed / Cancelled:** Yes No N/A**Bridge No:** 34-0006**Component:** SAS OBG**Summary of Items Observed:**

13E/14E/E1/E2 (Exterior)

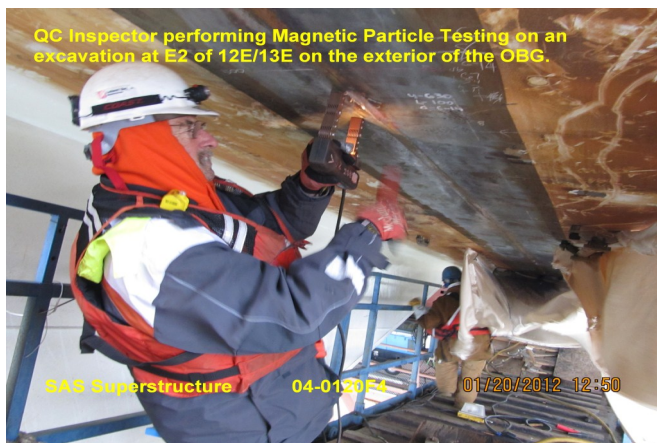
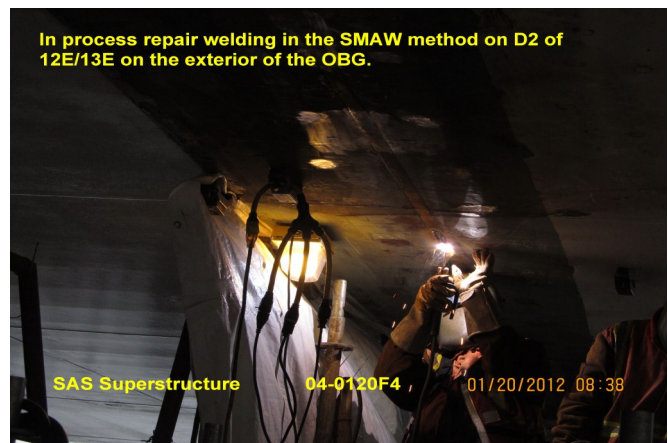
This QA Inspector randomly observed ABF welder Xiao Jian Wan performing the back-gouge operation of four (4) ultrasonic rejectable indications on "E1/E2" of 12E/13E located at "Y" 630 mm: (30 mm wide; 180 mm length; and 8 mm in depth), "Y" 260 mm: (25 mm wide; 150 mm length; and 10 mm in depth), "Y" 480 mm: (23 mm wide; 120 mm length; and 15 mm in depth), "Y" 1200 mm: (25 mm wide; 195 mm length; and 9 mm in depth). This QA Inspector observed QC Inspector Fred Von Hoff perform a Magnetic Particle Inspection (MT) of the excavation to determine the soundness of the metal. Upon completion of the testing this QA Inspector verified that no rejectable indications were present.

This QA Inspector randomly observed ABF welder Xiao Jian Wan (Welder ID 9677) performing the repair welding operation of ultrasonic rejectable indications as per the SMAW process in the (4G) overhead position on "E1/E2" of 12E/13E on the exterior of the OBG. This QA Inspector observed the use of E7018-H4R electrodes and QC Inspector Fred Von Hoff verify that the preheat temperature was at the minimum of 93 degrees C and that the welding parameters (Amps=135) were in accordance with WPS D1.5-1001- Repair. The welding parameters observed at this location appeared to be in general compliance with approved WPS and the contract specifications. This QA Inspector made subsequent observations and noted that the work is in progress.

This QA Inspector randomly observed ABF welder Wai Kit Lai (Welder ID 2953) performing the repair welding operation of an ultrasonic indication as per the SMAW process in the (4G) overhead position on “D2” of 12E/13E. The welder utilized E7018-H4R electrodes from a portable baking oven and applied heat on the site to a minimum of 93 degrees C. The QC Inspector was observed monitoring the welding and the parameters to satisfy both were in accordance with WPS D1.5–1001- Repair. The welding parameters observed at this location appeared to be in general compliance with approved WPS and the contract specifications. This QA Inspector made subsequent observations and noted that the work is in progress.
